1663 Add Drop Multiplexer-universal (ADMu)

Release 6.1

Alarm Messages and Trouble-Clearing Guide

365-312-843R6.1
CC109665604
Issue 1
March 2008

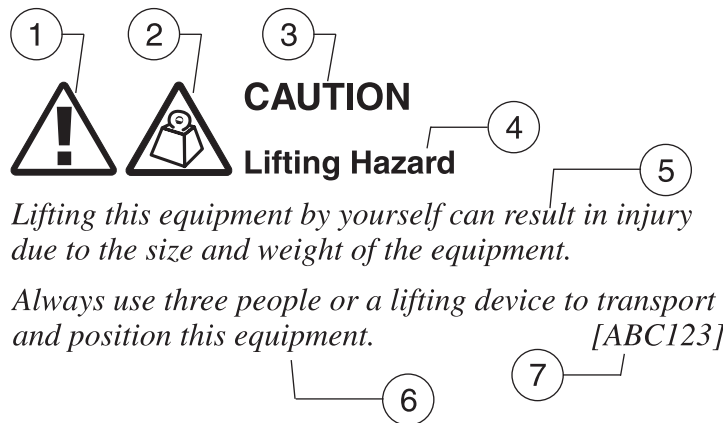
General structure

Hazard statements include the following structural elements:

Item	Structure element	Purpose
1	Personal-injury symbol	Indicates the potential for personal injury (optional)
2	Hazard-type symbol	Indicates hazard type (optional)
3	Signal word	Indicates the severity of the hazard
4	Hazard type	Describes the source of the risk of damage or injury
5	Damage statement	Consequences if protective measures fail
6	Avoidance message	Protective measures to take to avoid the hazard
7	Identifier	The reference ID of the hazard statement (optional)

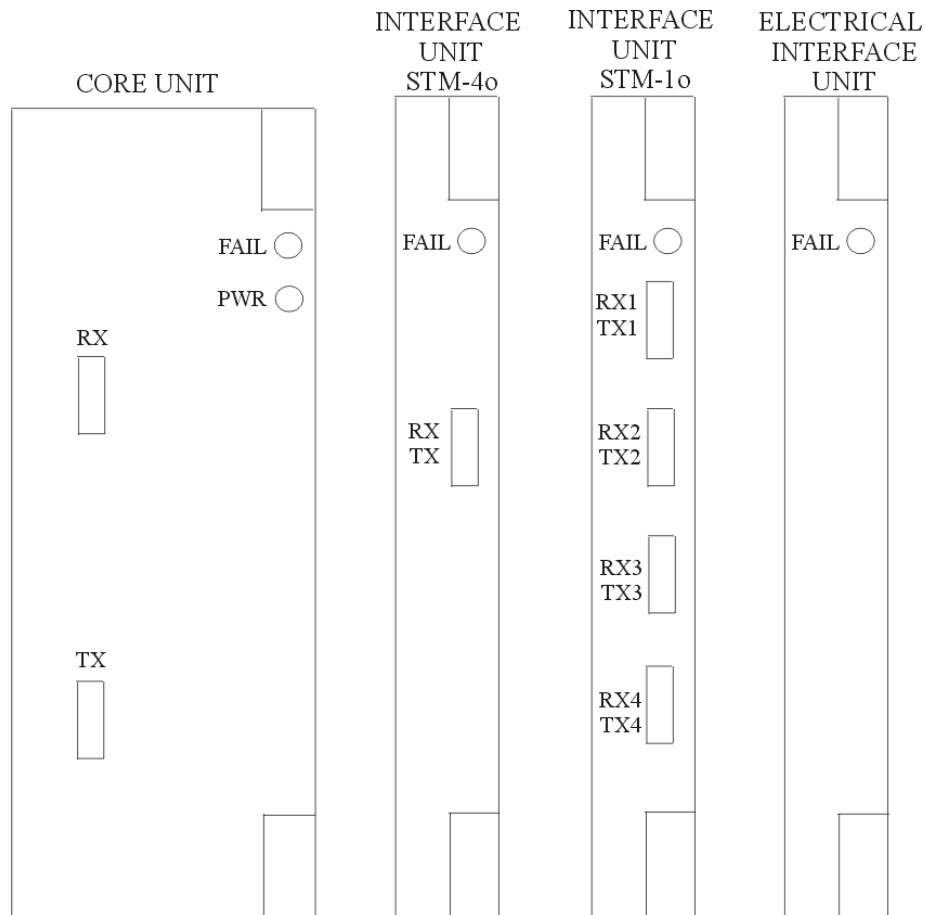
LEDs on front plate

The next figure shows the position of the LEDs on the Core Unit and on the Interface Units (not to scale). The front plate of the System Controller is shown in the next paragraph “User Panel LEDs and keys”.

When the unit is inserted into a shelf which is already powered up, or when power is applied to a shelf which contains units, the Unit LED will be lit immediately. After that the control system takes into account the mode of operation of the slot and, if applicable, the mode of operation of the port(s) on the unit and controls the Unit LED accordingly. In case of a failure of the on-Board Controller the LED will remain lit.

A permanently lit LED on a unit indicates a hardware fault on that particular unit and the unit should be replaced by a spare one.

A flashing LED means that there is something wrong with the transmission signals which are terminated on that unit (fibre break e.g.). The Integrated Transport Management-Craft Interface Terminal (ITM-CIT) should be used to determine the type of failure.

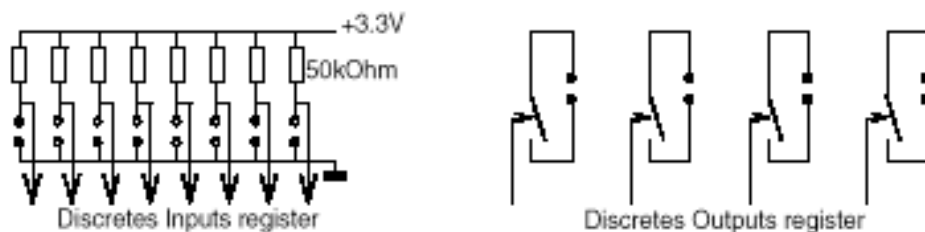
The MDO contacts are capable of sustaining the product of above mentioned current and voltage during transitions.

MDOs are driven on command from a management system (*Navis*[®] OMS or ITM-CIT).

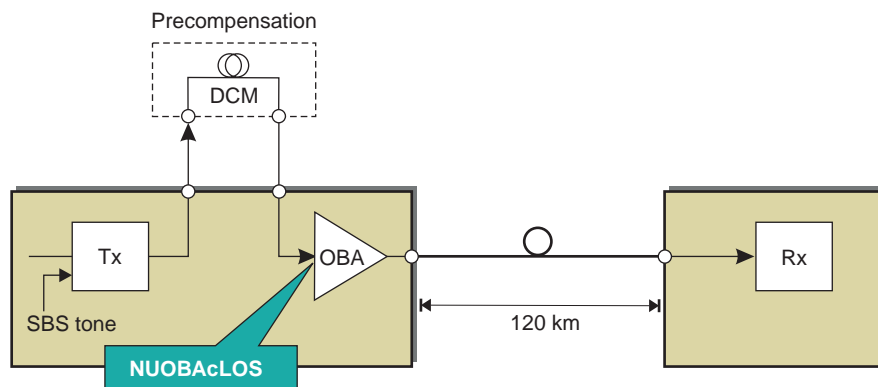
Alarm identifier	NUOBACLOS
Information	There is no optical input power at the optical booster amplifier of the STM-64 very long haul interface unit (LKA350). Please also refer to the diagram subsequent to this table.
Alarm category	Equipment
ASAP	equipment
Alarm severity (default setting)	Prompt
Reporting state (default setting)	Reported
Local indications	The red fault LED on the STM-64 very long haul interface unit (LKA350) is lit.
Cause	<ol style="list-style-type: none"> 1. Fault in the cabling to/from the Dispersion Compensation Module (DCM). This may be defective fibers or loose connectors. 2. Fault in the transmitter part (Tx) of the LKA350 unit. 3. Receive-side fault in the amplifier part (OBA) of the LKA350 unit. 4. Possibly the fibers inside the DCM are defective.
Actions	<ol style="list-style-type: none"> 1. Check the cabling (including the connectors) to/from the Dispersion Compensation Module (DCM). 2. Measure the optical power at the Tx output of the LKA350 unit. Replace the LKA350 unit if the optical output power is too low. 3. Measure the optical power at the OBA input of the LKA350 unit. Replace the LKA350 unit if the optical input power is <i>in</i> the nominal range. 4. Replace the DCM.
